The Critical Role of Gasket Installation Procedures & Communication

Lessons to be learned from the 1988 Piper Alpha disaster.

RON FRISARD | Fluid Sealing Association member, AW Chesterton

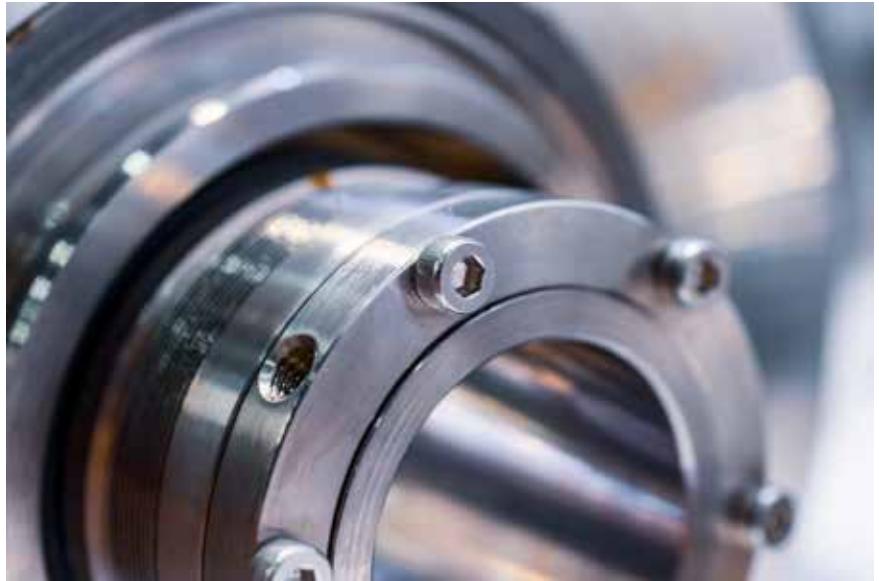
IMAGE 1: Sealing system (Photo credit: nordroden - stock.adobe.com)
